# Mech

# THE NAVY & MARINE CORPS AVIATION MAINTENANCE SAFETY MAGAZINE

Vol. 46, No. 1 Winter 2006-07

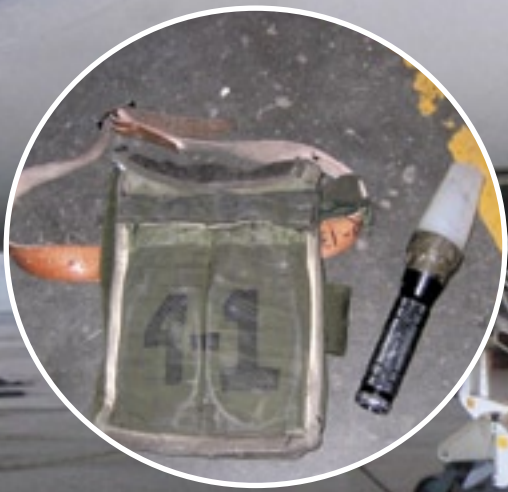
The birdcage area of the Prowler can be dark and often requires a flashlight during maintenance.

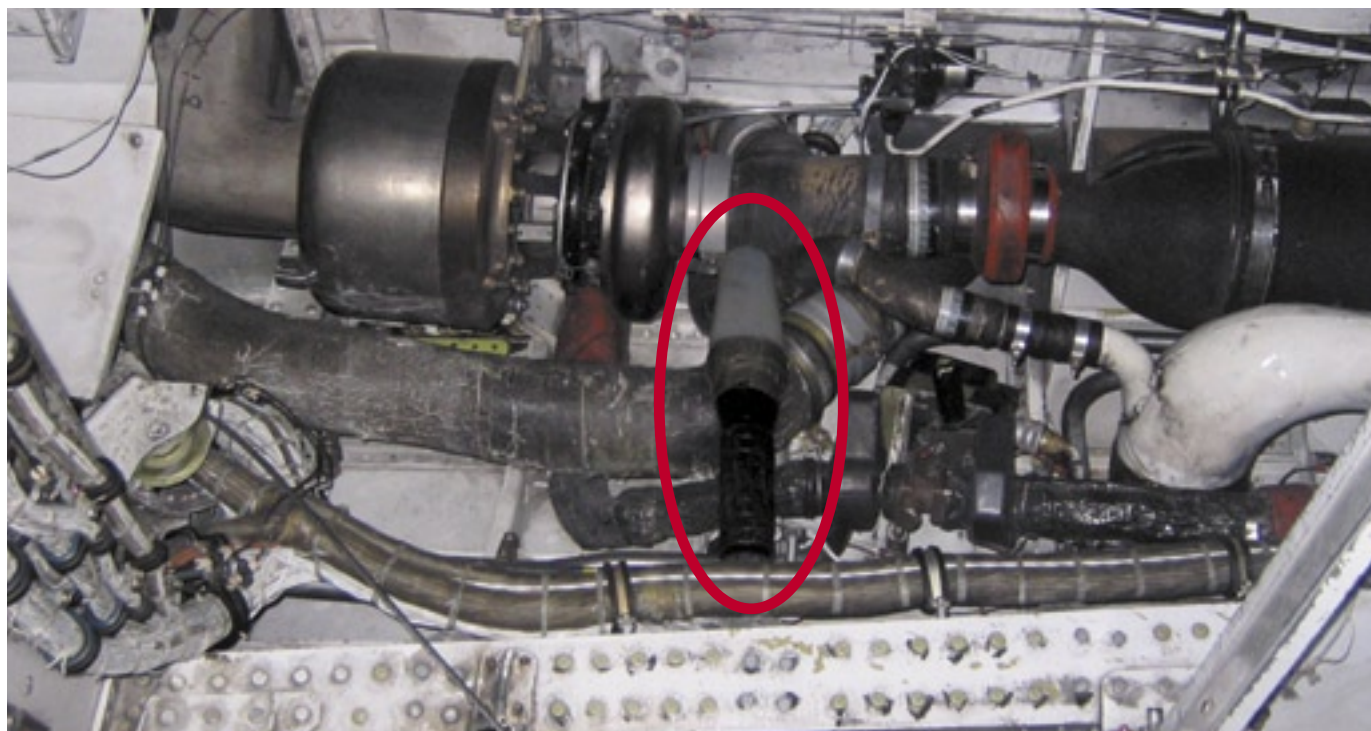
Flashlight found in the aircraft where it had been left.

By the time I arrived at the squadron spaces, a missing-tool report already had been started, and the aircraft was about to land. Once the aircraft was parked, I ran out to the flight line with the recovery crew and anxiously lowered the aft extensible platform (birdcage). To both my dread and relief, the flashlight was in the birdcage and was recovered. Fortunately, no damage to the aircraft had occurred.

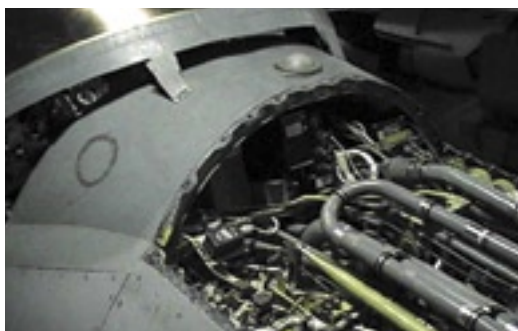
Top-deck relay is found under the turtle back panel.

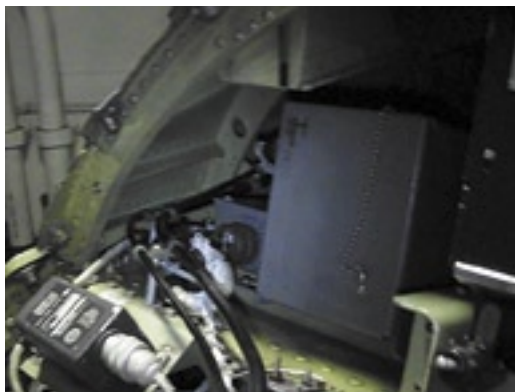
No. 1 relay and No. 2 relays are similar.

It's common for EA-6B electricians to change the No. 1 relay box but not the No. 2 box. When the electricians saw the gripe and ordered a replacement, they incorrectly assumed it was the No. 1 component.

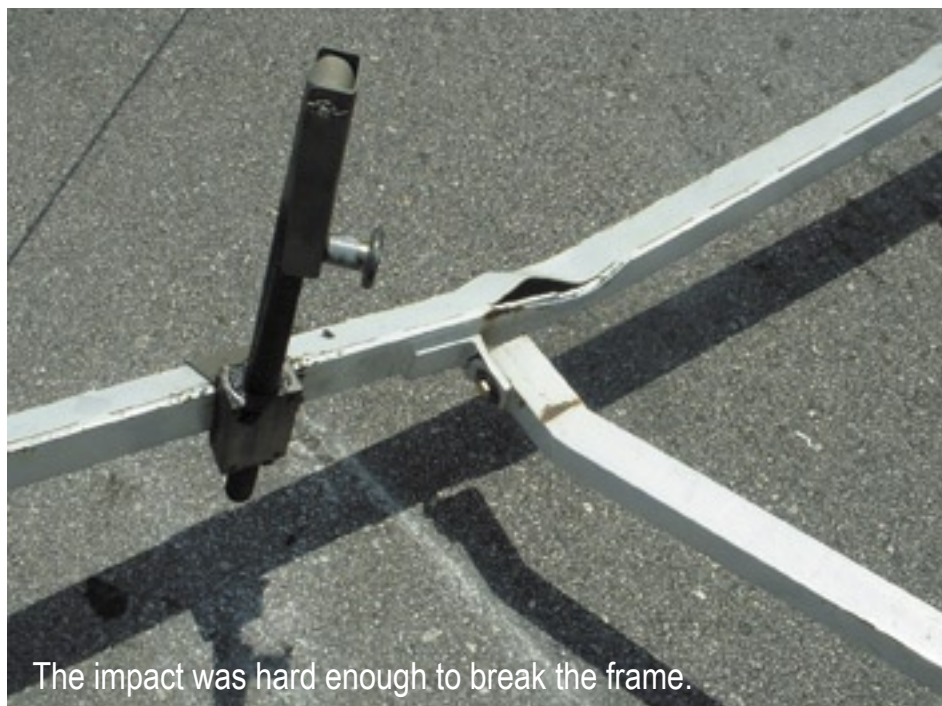
The impact was hard enough to break the frame.

None of the wires for the traffic light were broken, and cars were able to continue on their way. When the stand grabbed the light, it scraped along the ground for several feet and began bending at the base. I had been traveling only about 3 mph, and it's amazing that I caused \$3,000 worth of damage.

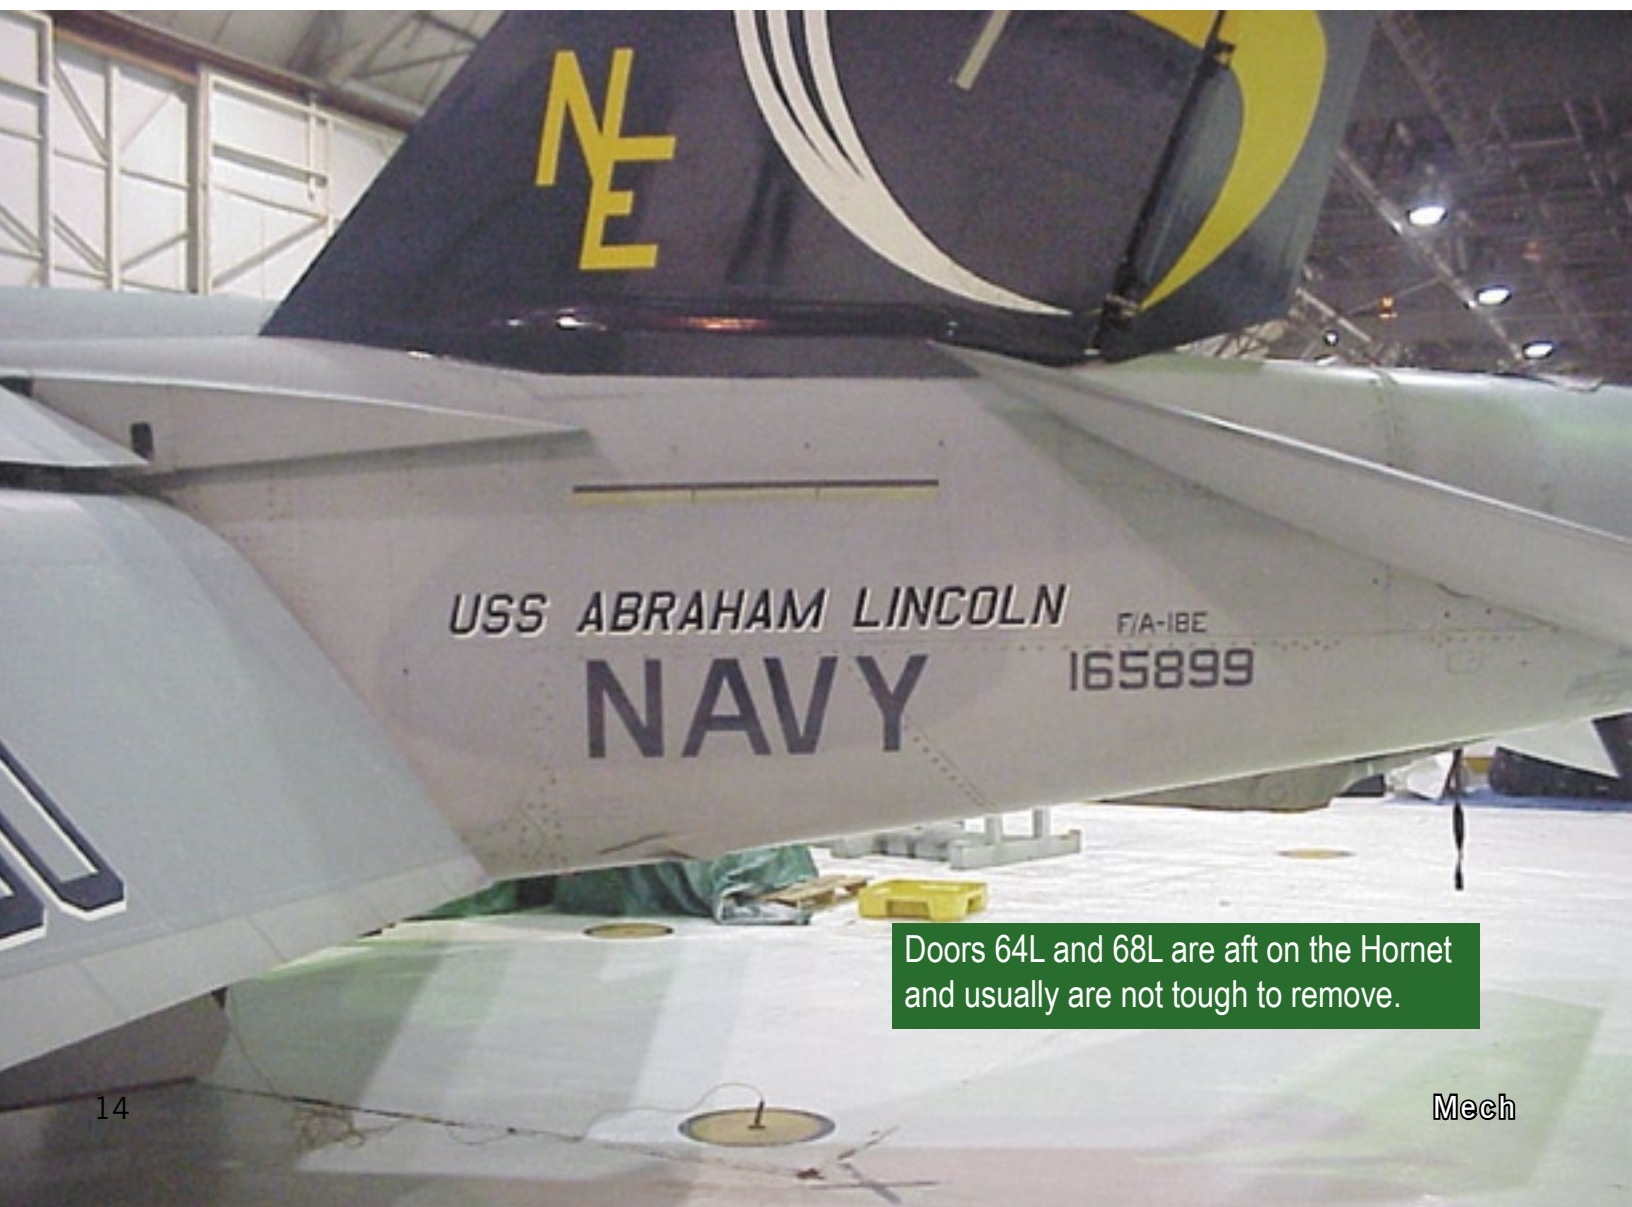
Doors 64L and 68L are aft on the Hornet and usually are not tough to remove.

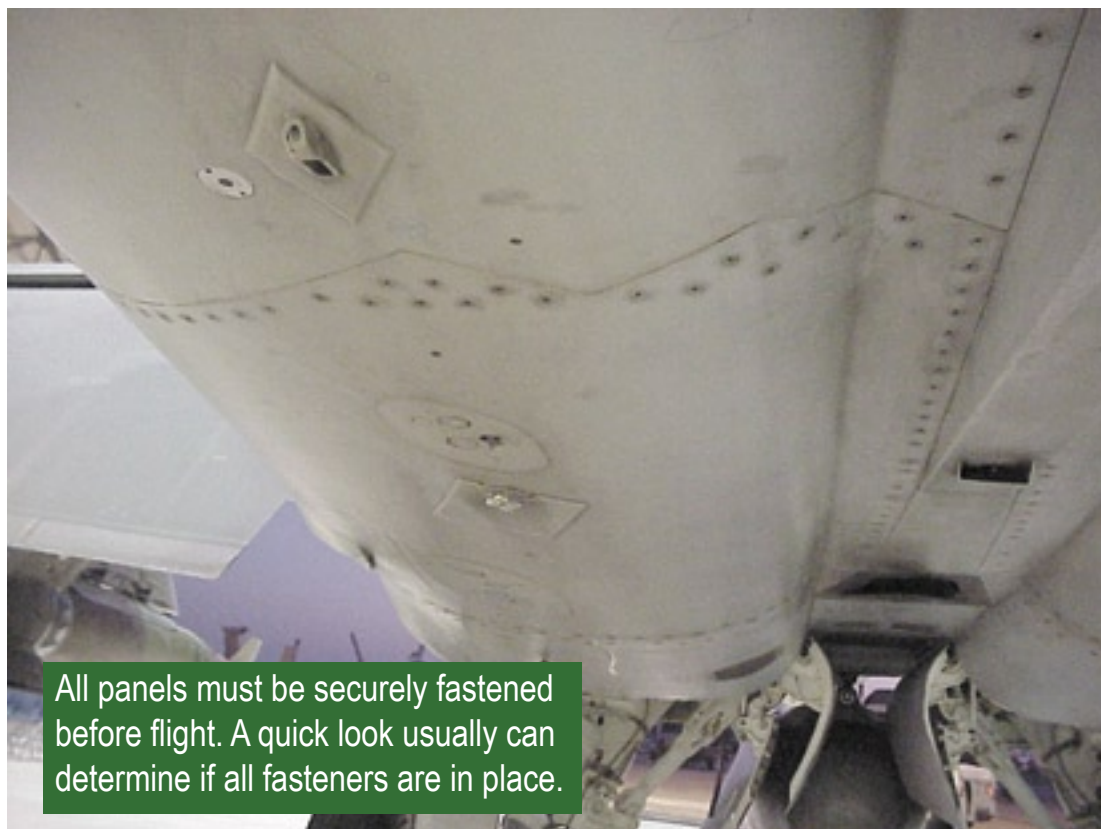
All panels must be securely fastened before flight. A quick look usually can determine if all fasteners are in place.

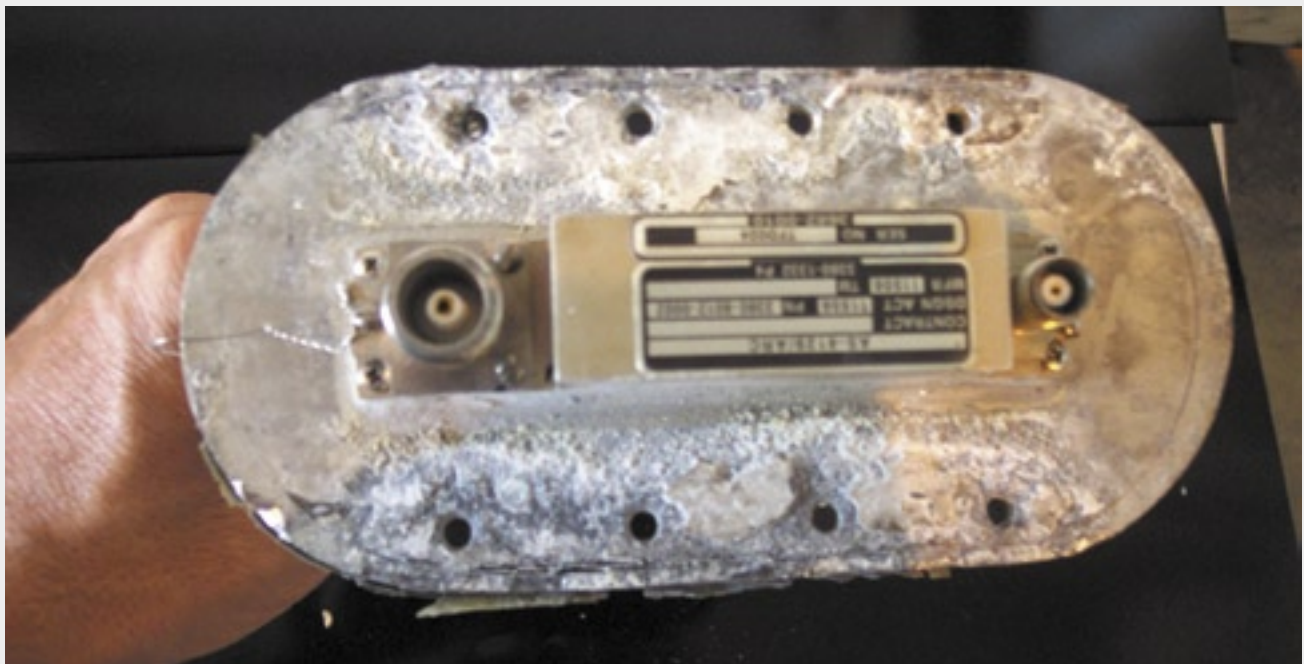
Intergranular and exfoliation corrosion found on an antenna base plate and aircraft skin.

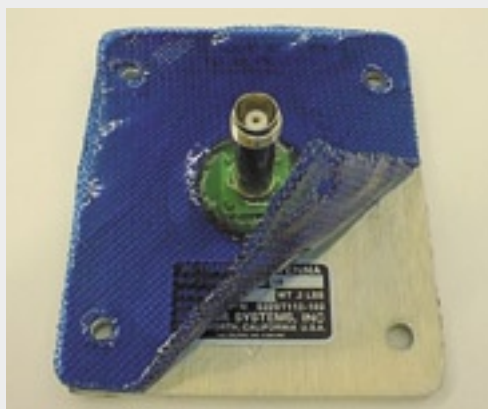
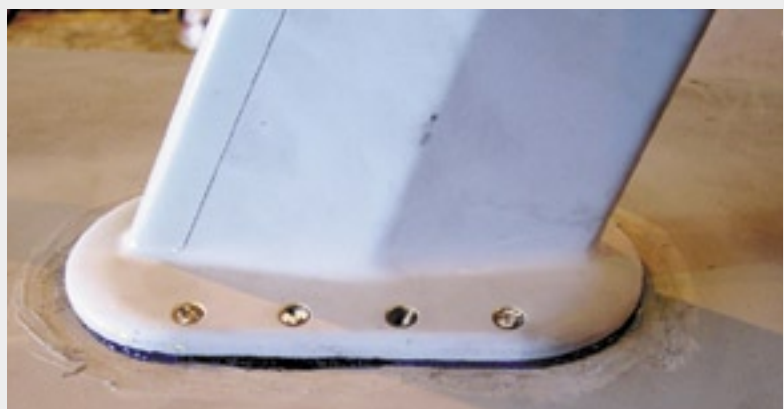
Application of the AvDEC™ conductive gasket and protective gel on an antenna base allows the gel to squeeze out around the antenna base.

A new commercial-off-the-shelf-technology (COTS), produced by Aviation Devices and Electronic Components (AvDec™), is a conductive gasket, consisting of a cured polyurethane gel that encapsulates an aluminum wire mesh, which has been identified to provide improved electrical bonding between aircraft aluminum substrate and the mounting base of aircraft antennas and static discharger mounts. The focus of this technology is to seal and protect mating areas against moisture and subsequent corrosion while at the same time provide a mechanism for electrical bonding and grounding. The gasket is designed so that once the mounting screws are installed and torqued, com-

pression squeezes some of the polyurethane gel to the outside edge of the antenna mount providing a small perimeter seal, thus eliminating the need for additional polysulfide sealing. That sealant is required each time a technician removes and replaces an antenna or static wick mount. The polysulfide sealant (MIL-PRF-81733) contains hexavalent chrome as a corrosion inhibitor and is used around the perimeter at the base of the antenna or static wick mount to prevent moisture intrusion. These technicians are being exposed to carcinogens that are embedded within the polysulfide sealant, and the excess sealant is a hazardous material that must be disposed of properly. The installation process is a labor-intensive procedure that severely impacts aircraft availability and operational readiness. With approximately 4,000 aircraft in the fleet, the use of the AvDEC™ conductive gasket will eliminate the requirement for using chromated polysulfide sealants, thus saving thousands of dollars in labor, material and disposal costs. Additional benefits include the elimination of airborne communication precipitation static (P-static) discrepancies caused by corrosion.

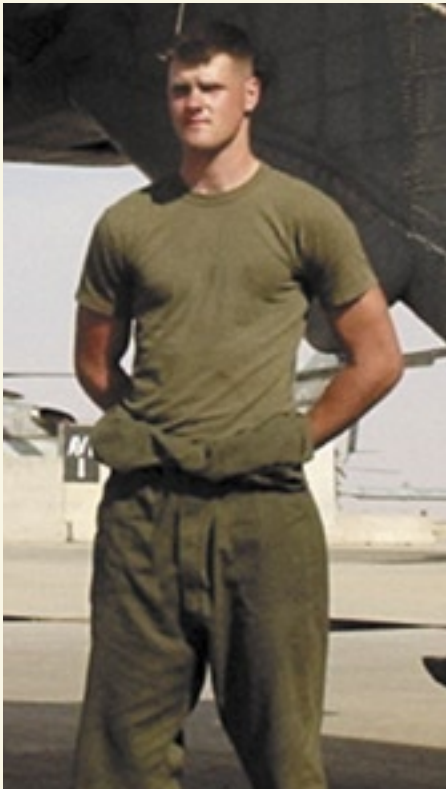
While doing a phase inspection of the horizontal stabilizer on a CH-53E helicopter, Cpl. Ruark discovered numerous loose fasteners on the primary structure of the stabilizer, near the mounting point for the stabilizer strut. A closer look showed two hi-loc fasteners in the fitting assembly also were loose. These fittings are essential for attaching the horizontal stabilizer to the fuselage of the aircraft.

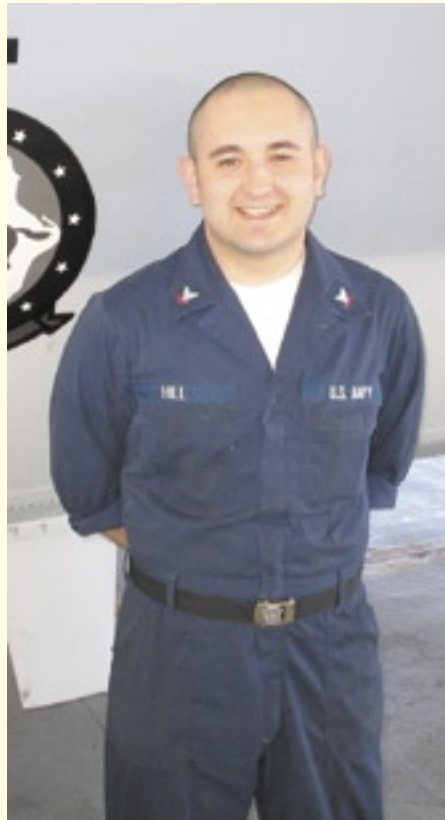
Petty Officer Hill was doing a daily inspection on a C-130T during night flight-line operations and discovered two 8-inch cracks on the skin section of the starboard upper wing. The cracks were barely discernible and were a very good find. He immediately notified maintenance control and QA to investigate the damage.

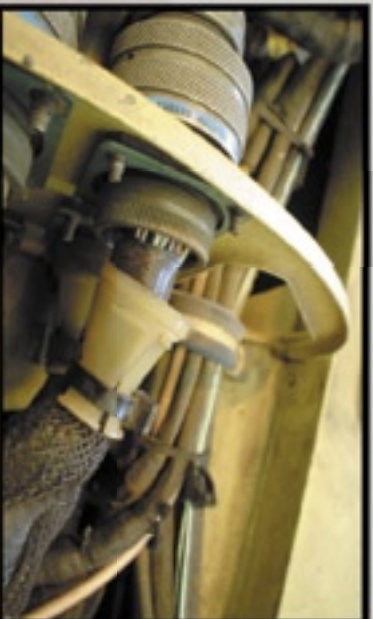
Broken back shell, wiring exposed.

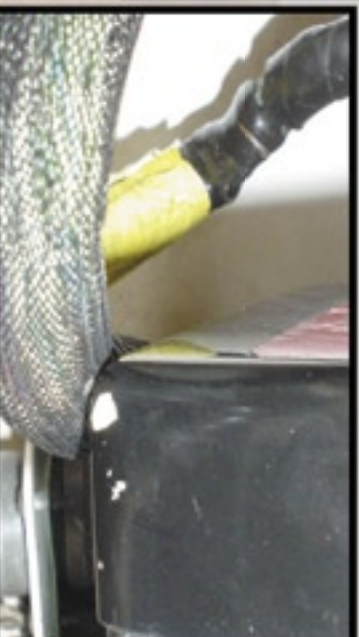
Wiring harness pinched and chafing.

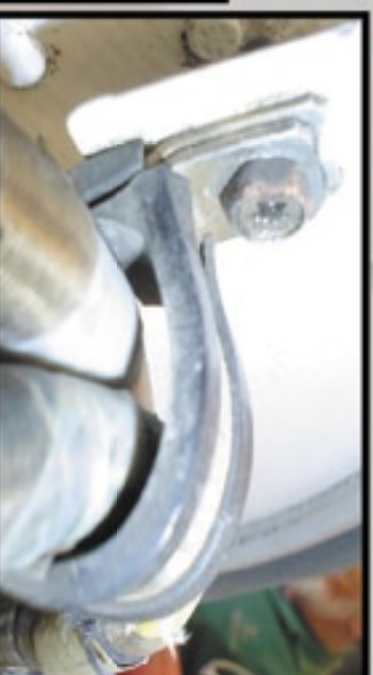
Wrong clamp installed, chafing wiring.
